Lake Park Foot Bridge – Peer Assessment

**Lake Park
Milwaukee, Wisconsin**

June 28, 2016

**Olson & Nesvold Engineers, P.S.C.
7825 Washington Avenue South
Suite 100
Bloomington, Minnesota 55439
www.one-mn.com**

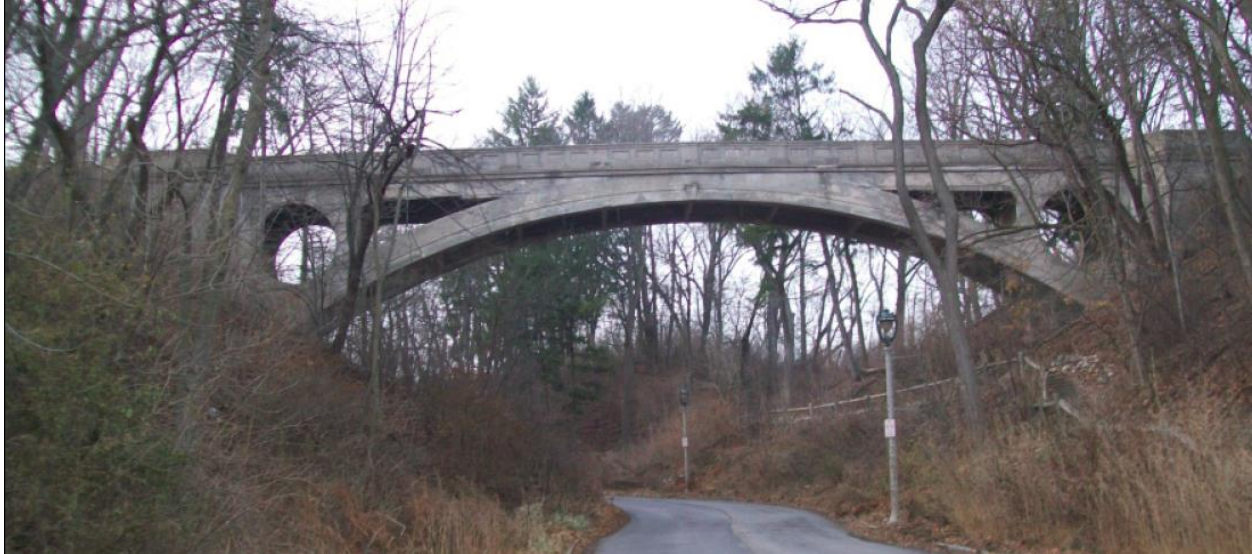
Looking west at the bridge (Photo from the Graef Report)

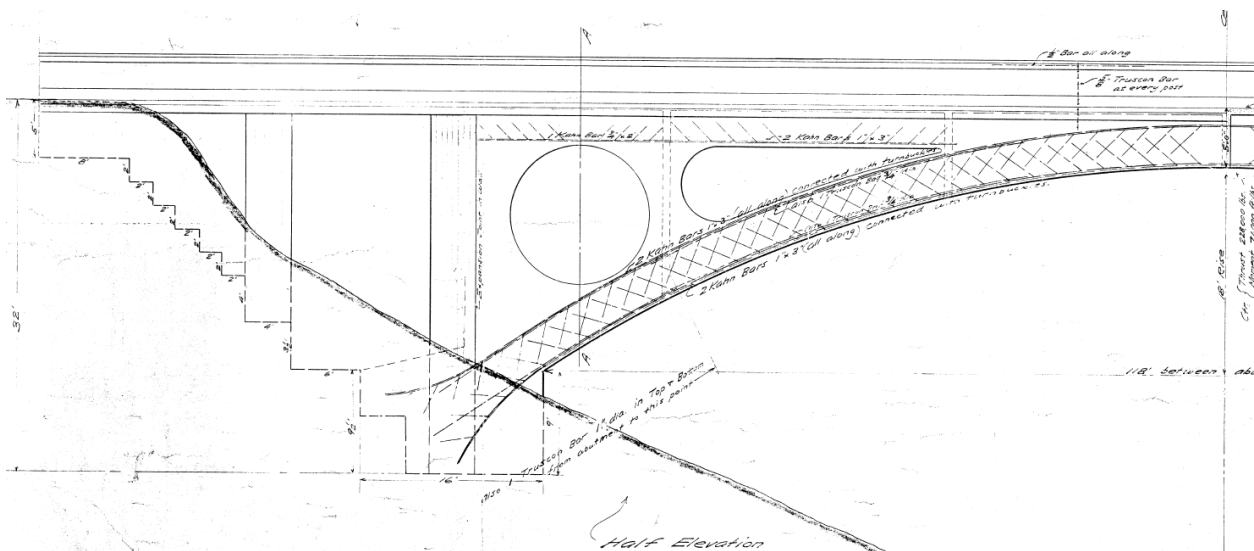
The Lake Park Footbridge is a reinforced concrete rib-arch bridge. The ribs support spandrel walls with unique openings (one is tear-drop shaped, the other is circular). Atop the spandrel walls is a reinforced concrete deck and solid concrete parapet railings. Constructed in 1906, parts of the structure contain historic reinforcing steel elements (Kahn System). A detail from the original plans is provided below:

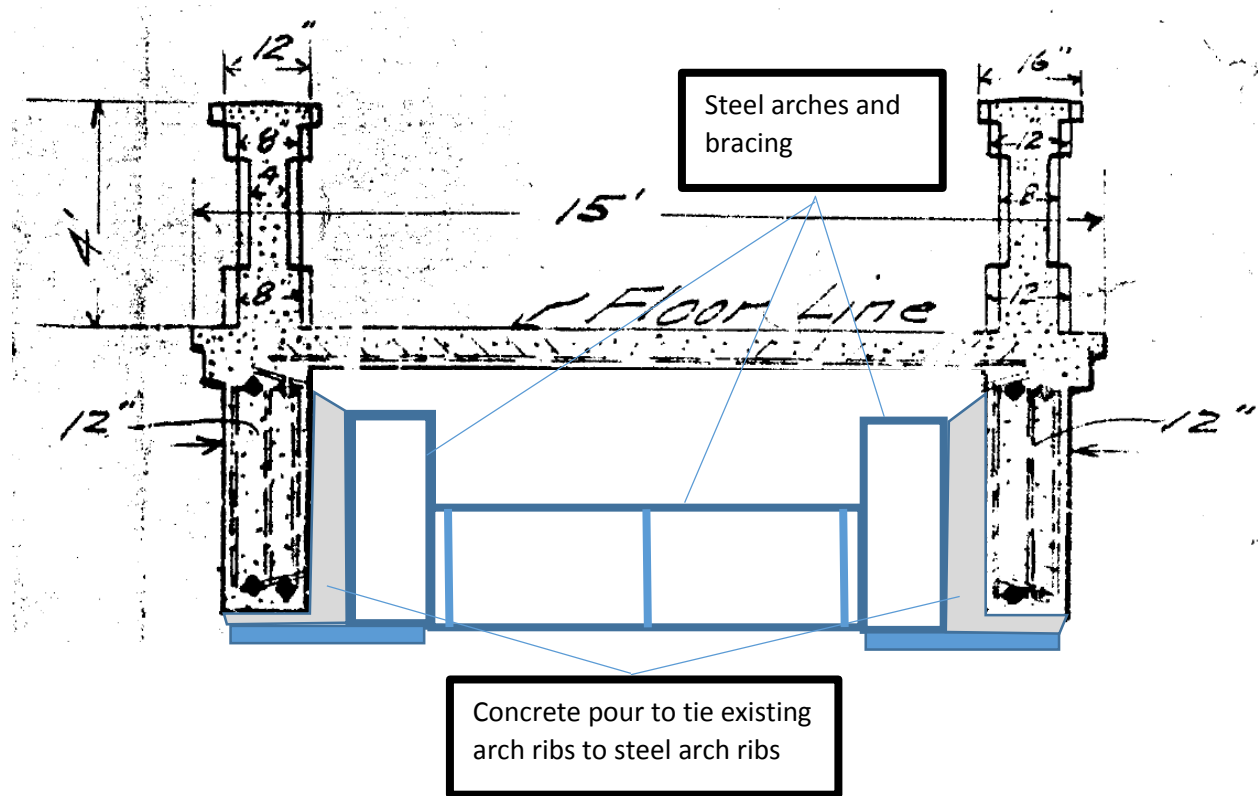
One of the concerns Graef highlighted in their report was that the arch ribs would reach the end of their service life after another 15-25 years. We concur with Graef that the existing arch ribs would likely be compromised to a significant degree, if simply patched as they have been in the past. The corrosion on the Kahn bars would continue and the spalling would continue.

To address this service life concern, we believe a new structural steel framework (including steel arch ribs) could be constructed just inside of the existing arch ribs. The steel arch ribs would be galvanized to provide some passive cathodic protection to the Kahn bars in the existing arch ribs. In addition, a support plate would be detailed under the existing arch ribs to prevent any future spalls from dropping below. The support plate would function much as a lintel does in masonry construction. The steel

framework could be designed to carry all the loads between the abutments or some smaller fraction. Resulting in a reduced load demand for the existing arch ribs.

The steel frame work would also be detailed to accept construction walkway loads.

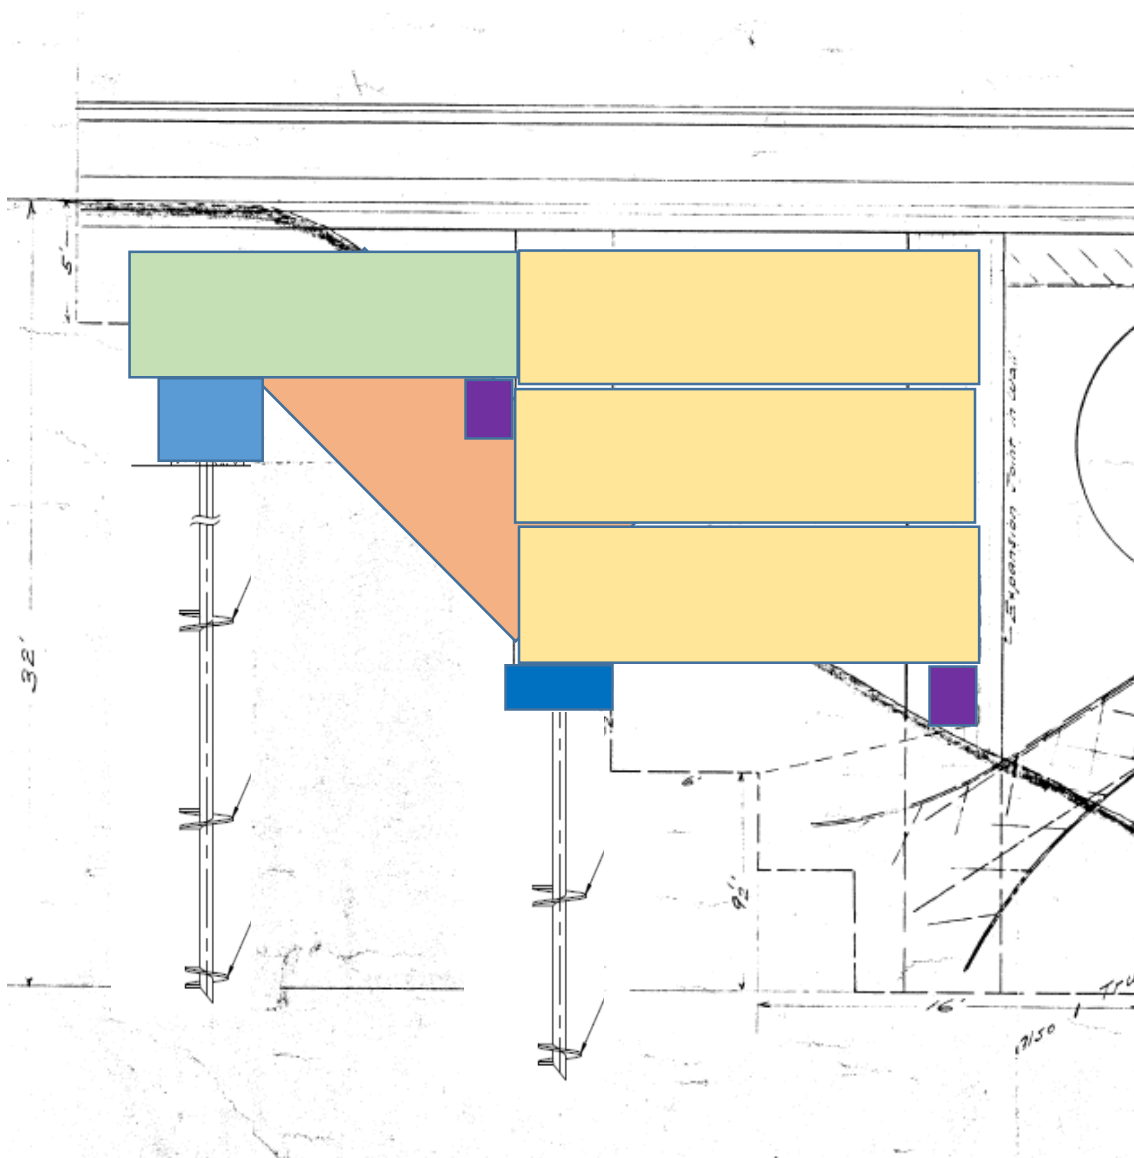
The abutments are in extremely poor condition and in a difficult to access location. There is extensive deterioration in both abutments that includes shearing of the vertical walls due to unbalanced earth pressures.

A handful of box culvert sections oriented vertically would be used as the “backbone” to support wall elements. These could be stepped to mimic the existing wall foundation steps. The sections would be “stitched” together with galvanized threadbars to create a “jumbo” beam that spans from the vertical wall over the thrust block to the supports with the helical anchors.

The abutment beam consists of a purple reaction pad constructed on the top of the thrust block. It includes a dark blue footing to support the yellow box culvert sections. After the yellow box culvert sections are in place a purple support block would be cast against the yellow box culvert sections. The vertical helical anchors are envisioned to reach a competent geotech level at the same level as the bottom of the thrust block. Atop the helical anchors a pile cap is cast. Upon the pile cap and the second purple block the green box culvert section is installed. The last step in the construction of the “mega” beam is the infill triangle wall (light orange).
